OV-1 MISHAP EXPERIENCE REPORT

FY 1972 through FY 1974

by
Mr. Paul R. Ewing

**Environmental Factors/Fixed Wing Division
Directorate for Aircraft Accident Analysis and Investigation**

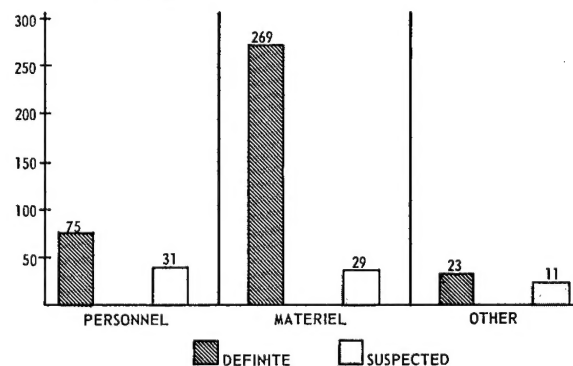
FIGURE 1.—Cause Factors for 376 Mishaps

Three hundred and sixty-seven definite and 71 suspected cause factors were recorded for the 376 mishaps reported. These are shown in figure 1. For the 58 damaging mishaps, 70 definite and 36 suspected cause factors were recorded (figure 2). A brief comparison of figures 1 and 2 reveals that although a majority

of mishaps involved materiel cause factors, personnel cause factors were predominant in the damaging mishaps.

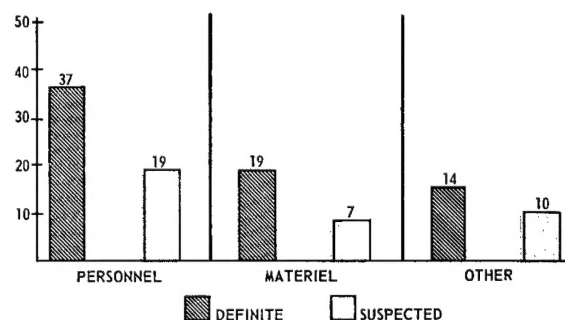
FIGURE 2.—Cause Factors for 58 Damaging Mishaps

Although materiel dominated the definite cause factors recorded for all mishaps (72%), personnel was recorded as the leading definite cause factor in damaging mishaps (53%). Twelve (21%) of the damaging mishaps accounted for \$13,436,402 (99%) of the damage and all of the injuries and fatalities. Materiel factors referenced in this report include failure of parts and components from all causes, i.e., prior over-stress, improper maintenance, etc.

More exacting standardization, especially in the area of emergency procedures, and increased command emphasis on the use of checklists, will serve to reduce the number and severity of mishaps resulting from personnel cause factors.

Immediate reporting of all materiel deficiencies through the Equipment Improvement Recommendation (EIR) program in accordance with TM 38-750 is the best method we have of reporting unsatisfactory equipment and influencing improvements and/or modifications when necessary. With improved materiel and components, materiel-related mishaps will decline.

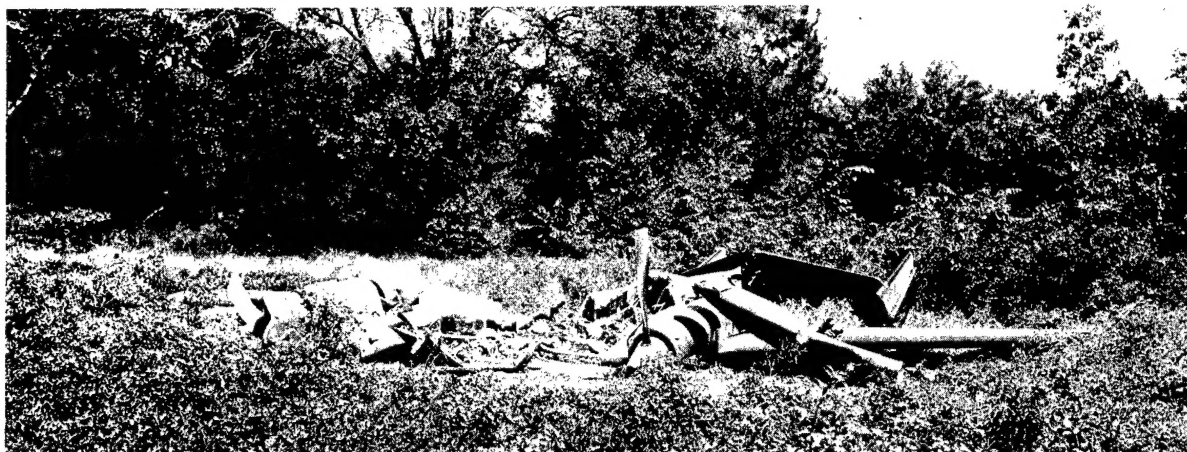
ACCIDENT NO. 1

ACCIDENT NO. 1-IP and pilot took off for a checkride and climbed to 7,500 feet. After entering the upper airwork area, IP had pilot do some unusual attitudes, including recovery from near vertical flight and inverted flight. Pilot went into series of power-on stalls in cruise configuration (clean), then with gear and flaps

extended (dirty) at approximately 10,000 feet msl. IP took control of aircraft and placed it in power-on "dirty" stall while pilot diverted his attention out the left window. Before relinquishing control of aircraft, IP pulled No. 1 engine fire handle, thus shutting the fuel off to No. 1 engine to practice an actual engine failure.

Since the fuel is shut off at the wing root, approximately 4 to 5 seconds are required before the engine actually quits. As pilot lowered nose, engine quit. Pilot then moved power lever of No. 2 engine to what he thought would produce 60 pounds of torque. Both aviators later commented that approximately 80 pounds of torque was developed by No. 2 engine. At that time, the aircraft rolled into a 30° left bank with a slight nose-down attitude. Pilot applied full right rudder and aileron, reducing the left bank to approximately 10°. IP took control and moved No. 2 engine power lever to flight idle while still applying right rudder and aileron. At this point, aircraft suddenly snapped to left, pitched down, and entered spin. IP then feathered propeller of No. 1 engine, retracted landing gear and speed brakes, and reduced flap setting from 45° to 15°. Noticing the extreme nose-down attitude, IP retracted remaining flaps while still maintaining right rudder and aileron. Aircraft then pitched up and continued spinning rapidly to left in near level attitude. The altimeter was indicating approximately 9,500 feet msl when the aircraft banked to the left approximately 45°. Aircraft then returned to level attitude. IP tried various control inputs during descent and, at approximately 7,500 feet, he told pilot to eject at 5,000 feet. At 5,000 feet the IP ejected and at approximately 4,500 feet the pilot ejected. Both ejections were successful.

This accident was caused by the IP placing the aircraft in a dangerous situation in that he induced an actual engine-out condition with the aircraft in a stall attitude with landing gear, flaps, and speed brakes extended. IP was not

knowledgeable of the proper spin recovery techniques for the OV-1 as outlined in TM 55-1510-204-10/4.

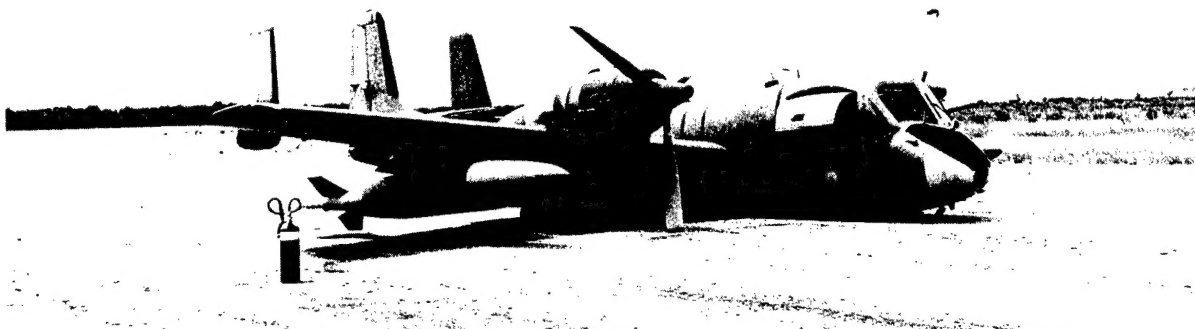
ACCIDENT NO. 4

ACCIDENT NO. 4—During training flight, IP gave pilot simulated single engine on takeoff. Pilot established single engine flight, flew the pattern, and landed without difficulty. During

the next traffic pattern, IP initiated simulated single engine as pilot was turning base leg. Landing gear was retracted and single engine flight was established. When landing was assured pilot extended gear and made prelanding check. Pilot turned final and aircraft was landed gear up. Aircraft slid to stop on runway and IP and pilot exited.

The suspected cause of this accident is that the rated student pilot initiated gear retraction during the final moments before touchdown, and the IP failed to recognize this soon enough. A suspected contributing factor is that the student pilot had a significant marital problem which was unresolved at time of accident. This could have served as a distracting influence.

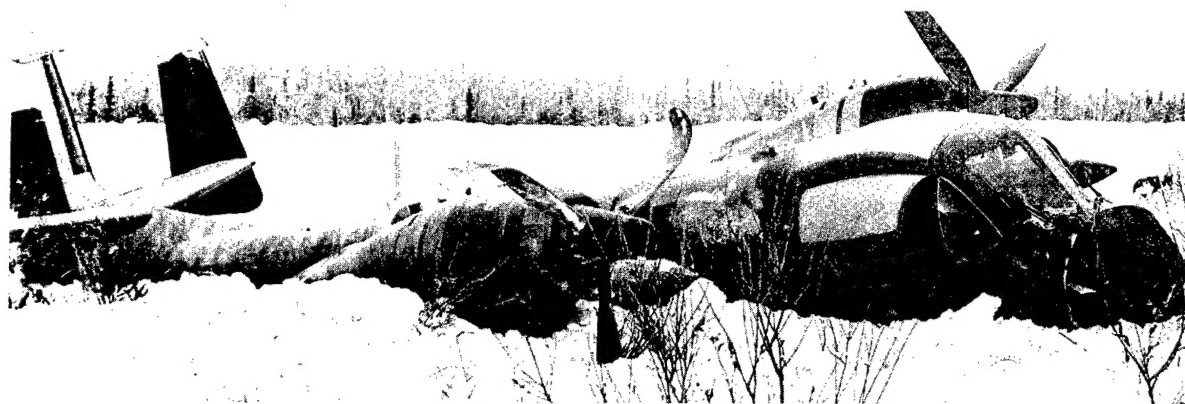
ACCIDENT NO. 6

ACCIDENT NO. 6—Pilot started aircraft and allowed temperatures to rise to normal. He then moved aircraft to runup area and performed normal runup, including cycling the propellers three times from low to high pitch. After approximately 20 minutes, pilot called for airport advisory and was given runway, winds, altimeter setting, and temperature. The runway surface condition was not included in the advisory. Pilot then taxied down runway 19 to avail himself of winds which favored runway 01. After he had taxied approximately 1,870 feet and attained a speed of 25 to 30 knots, he initiated the reverse check. At this time the No. 2 propeller failed to reverse. As rpm increased in both engines with No. 1 propeller in reverse and No. 2 at or near low pitch, aircraft began to turn to left. Pilot recognized the situation and began corrective action to realign aircraft on runway, applying right brake and rudder and moving

engine condition levers from reverse to ground idle position. This action had little effect on aircraft's ground track and pilot applied power to No. 1 engine in an attempt to check this movement, while continuing to apply right brake and rudder. At this point, aircraft had turned approximately 50° to 60° to left and pilot attempted to reverse propellers again. Realizing he had little or no control of aircraft at this point pilot began to prepare for impact. Both propellers were placed in feather position and aircraft departed runway 430 feet after initial application of reverse thrust and right main landing gear braking. Aircraft passed through an area of loose snow, crossed parallel access road, and skidded into large hard-packed snowbank.

The speed at which the aircraft was taxied before application of reverse thrust was excessive. The reason for the excessive speed was attributed to poor judgment on the part of the pilot and the lack of adequate ground reference points due to the snow-covered terrain. The application of differential power and the subsequent attempt to reverse only aggravated the already deteriorating situation.

A break in a wire leading to the No. 2 propeller reversing switch located on the No. 2 engine condition lever rendered the system inoperative. It is suspected that extreme cold temperatures and continued flexing of the wire during previous normal operations caused it to break.
